Montgomery Dam (NDS 427), Susquehanna
River Basin, Clearfield County,
Commonwealth of Pennsylvania. Phase I
Inspection Report.

PHASE I REPORT
NATIONAL DAM INSPECTION PROGRAM

Name of Dam: Montgomery Dam
State and State No. Pennsylvania, 17-L04
County Located: Clearfield
Stream: Montgomery Creek
Date of Inspection: May 11, 1978

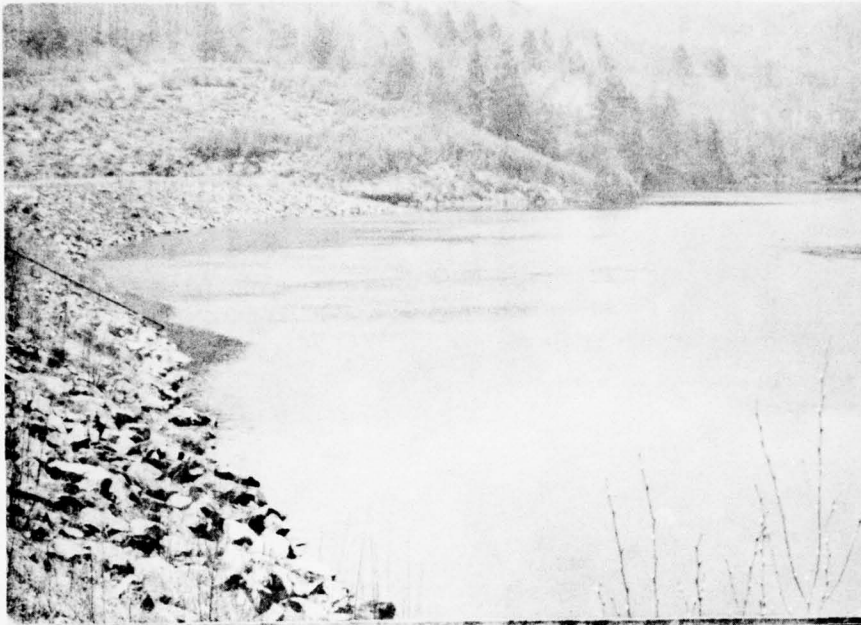
Upstream Slope

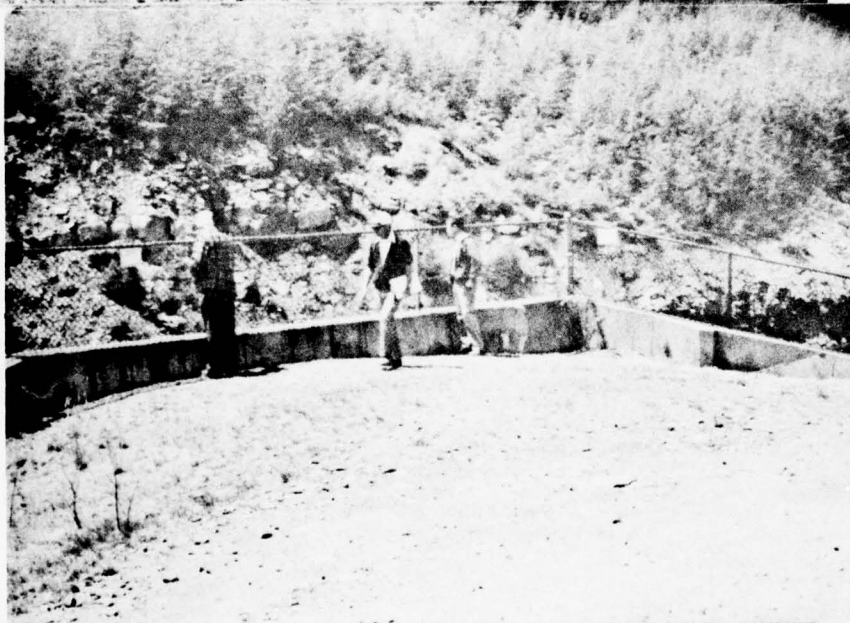
The top of the dam is cambered. Drawings indicate a low point on the breast of the embankment at Elev. 1411.0 or 6 inches below the spillway wall. As can be seen on the photograph Plate III, Appendix D, the dam breast is actually about 16 inches below the wall or at Elev. 1410.2. This low condition near the spillway is about 50 feet long and could have serious results if the lake would ever reach that level. The calculated discharge is 14,300 cfs for a pool elevation of 1411, but only 13,100 cfs for a pool elevation of 1410.2.

The visually observed low point in the embankment adjacent to the spillway could, however, seriously affect the capacity of retaining a high inflow without endangering the facilities.

Low Breast
At Spillway

4. The owner should correct the seepage condition at the end of the left spillway wall possibly by installing a drain and protecting the slope with riprap of sufficient size to control erosion.
5. The owner should raise the embankment adjacent to the spillway and should be aware that further erosion of the rock surface in the forebay area could become a hazard.

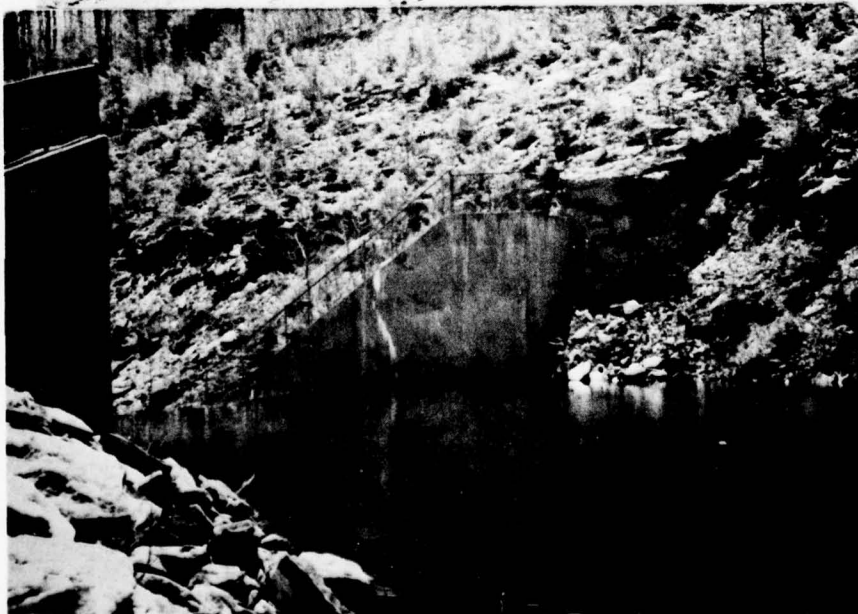
The rock at the right side of the approach channel is disintegrating and this could cause a dangerous situation in the future (Plate III, Appendix D).

Forebay

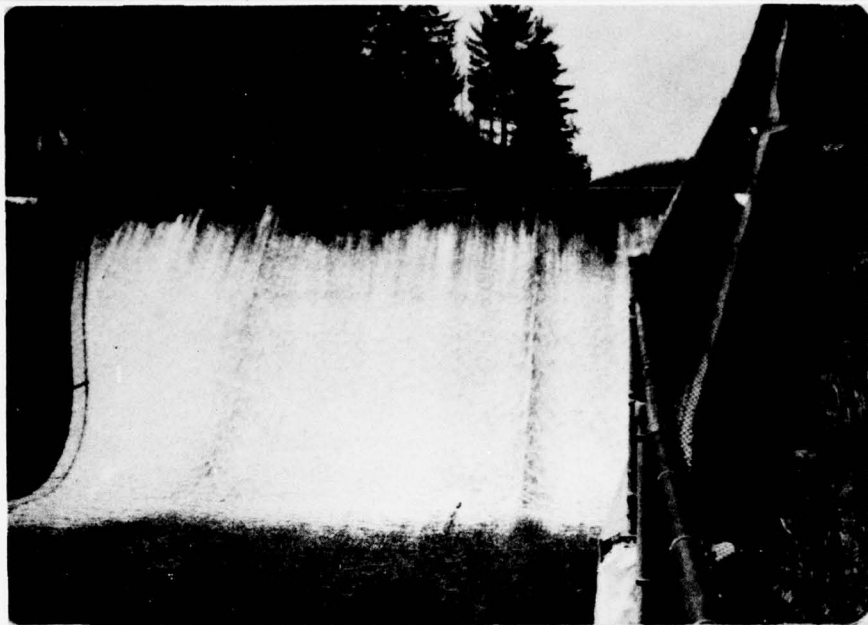
Spillway
Weir

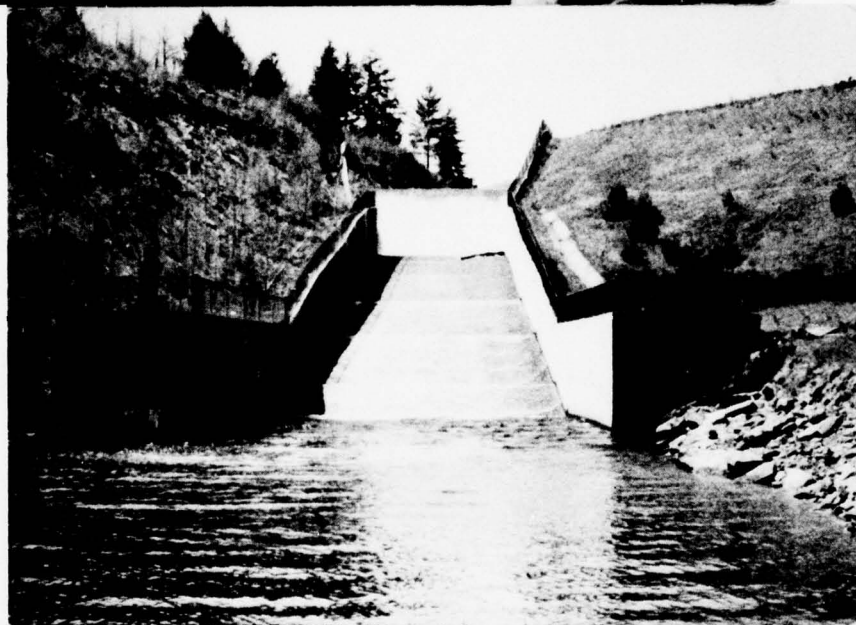
Spillway

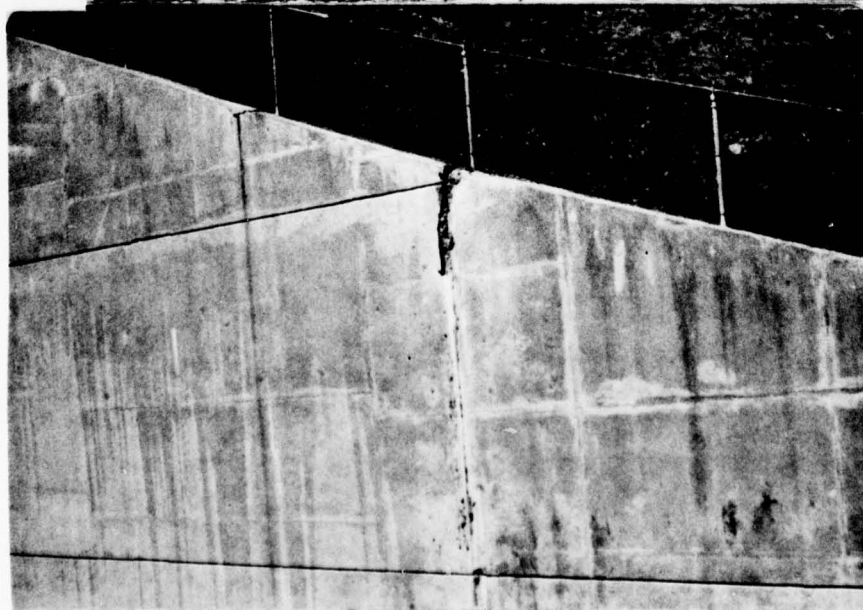
The appurtenant structures appear to be in good condition. The spillway had some cracking and spalling, mostly caused by shrinkage and temperature changes. The joint between the chute slab and walls should be inspected when pool level falls below spillway crest. This joint probably will require some grouting and sealing. The valves are operated at least once a year.

Spalling
Spillway Wall

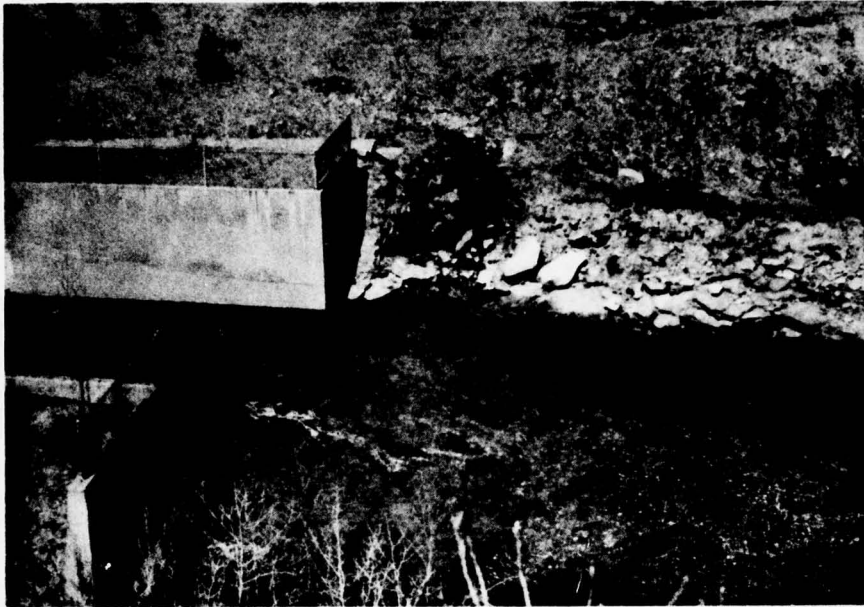
Erosion
Stilling Basin

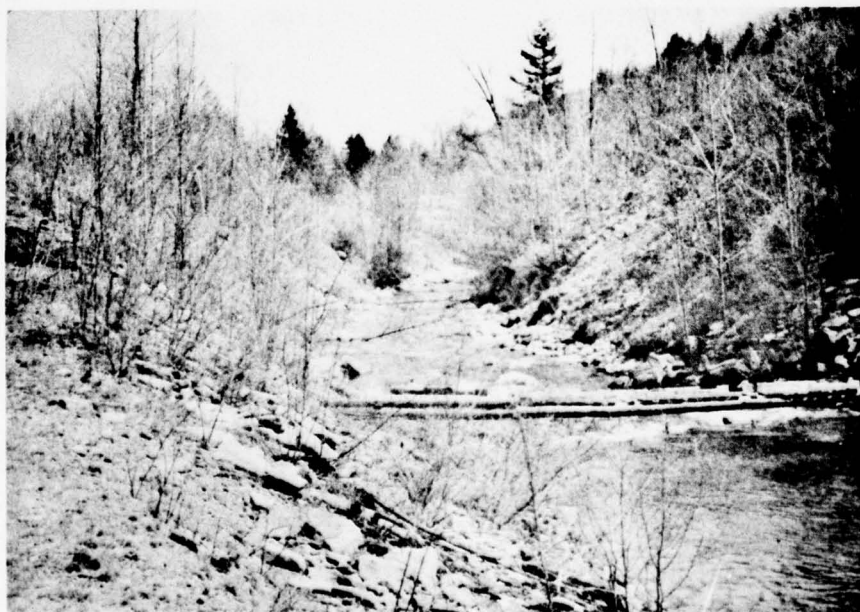
PLATE V

The immediate downstream channel appears to be clean and clear of obstructions (except a temporary wooden footbridge). See Appendix D, Plate V. A few log cabins and a camp are located about one mile downstream and close to the stream. The community of Hyde, Pennsylvania, is about three miles downstream and has several hundred homes and trailers. The area is very flat and a considerable loss of life and property could occur if the dam would fail. The hazard category for this dam is considered to be "High".

Downstream
Channel

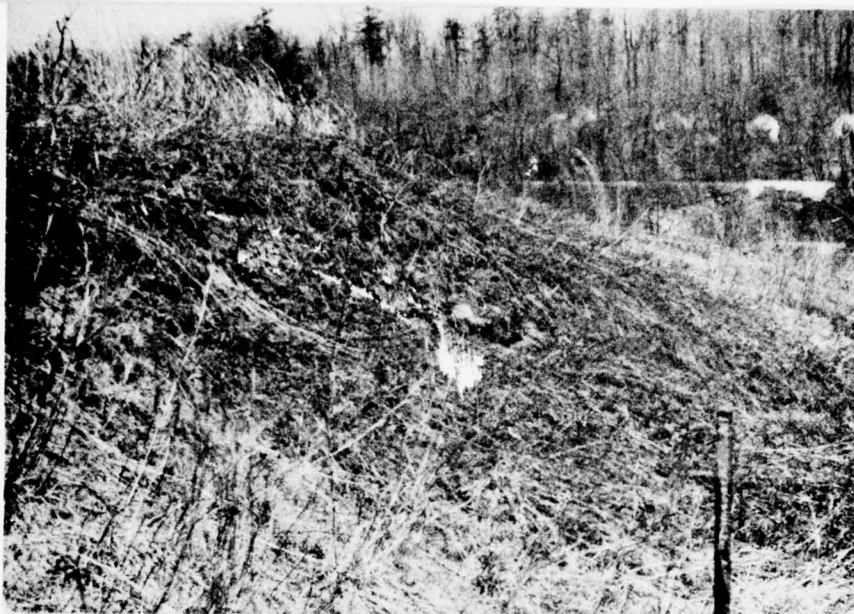
The upstream and downstream slopes have some growth of small brush, which should be controlled. The inspection observed a slide scar on the downstream slope approximately 265 feet east of the east spillway wall, with the head scarp about 28 feet from the centerline of the top of the embankment. The slide appears to be shallow in nature with a 2 foot± drop at the head and a toe of typical heave about 43 feet down slope. A parabolic curve with the peak at the head of the slide scar and a horizontal distance of 50 feet± at the toe of the slide area would approximate the plan view shape of the distressed area. Seepage was noted as emerging from the slope at the toe of the slide. This seepage is reflected at a wet spot on the berm directly below the slide. Two other isolated seepage areas were also noted on the embankment slope and are located approximately on the sketches accompanying the visual checklist in Appendix A. Additional persistent seepage was observed in the area surrounding the outlet structure just below the valve chamber. This area is also noted on the plan in Appendix A.

Of particular concern is the slide observed in the embankment as described in Paragraph 3.1.b. In the event of a high pool level a continuing of this existing slide would likely occur with the possibility of deeper, progressive slides occurring at this location which would present a hazardous condition. Also of concern are the two other areas of seepage at about the same elevation of the dam as shown in Appendix A. Under a higher pool level there is a possibility of a slide occurring at these locations. The reason for the seepage occurring at this level of the dam is not known but could be due to the upper portion of the embankment being constructed of the more pervious, cohesionless fill (sandy silt). Although there is no supporting evidence, inadequate construction procedures could have resulted in the fill having a less than the desired density. Of lesser concern is the seepage at the toe of the dam near the valve chamber and wet area between the spillway wall and natural ridge. However, both conditions could worsen with time, as could the condition of loose rock that has fallen into the spillway channel.

Slide
Downstream Slope

1. The owner should investigate the cause of the slide and seepage on the downstream embankment slope and make necessary improvements.
2. The owner should investigate the cause and seriousness of seepage at other locations on the embankment and take necessary action to improve the condition.
3. The owner should investigate means for improving the toe drain near the valve chamber and outlet structure and implement improvements as necessary.

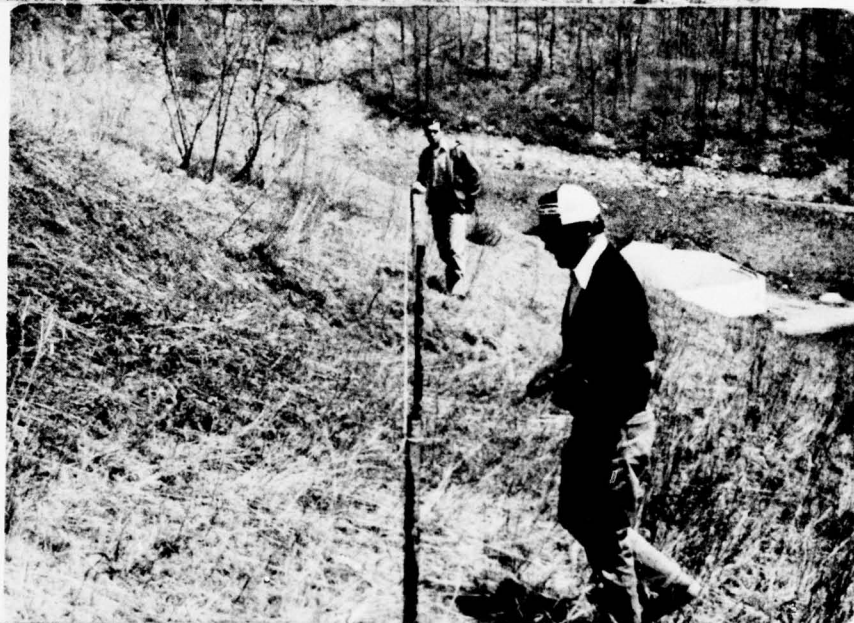
alignment between the stakes. Because of the passage of time since the stakes were installed, they are loose and are not considered reliable references for evaluating the actual behavior of the slide area.

Stakes In
Slide

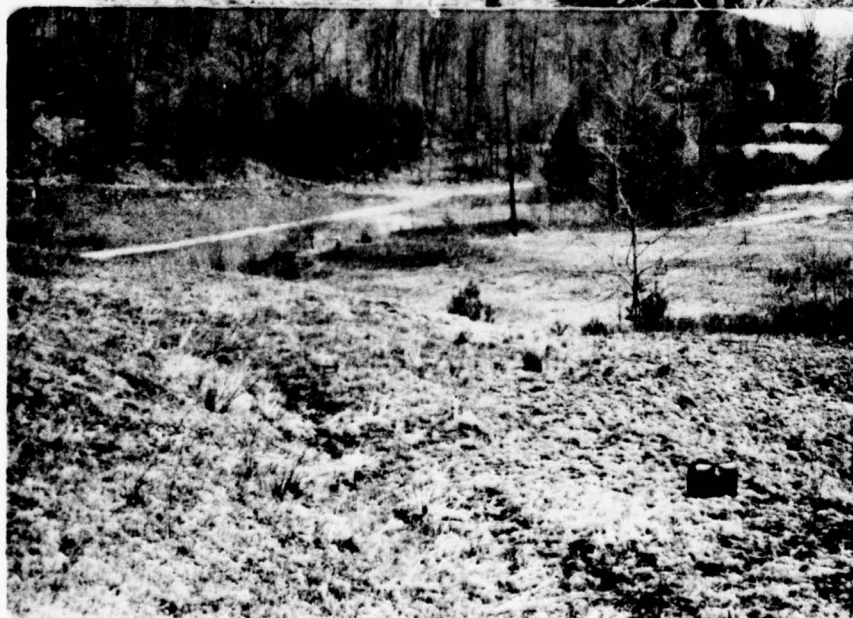
Wet Berm
